Survey report of a selected pilot site for development of a micro watershed management model for the EUCCR-PNG project (D 2)

*Survey report of a pilot site "Vaya Community, Kome LLG, Menyama District" for the project
"Strengthening food production capacity and the resilience to drought of vulnerable communities"*

DI Dr. Dominik Ruffeis

10.12.2019

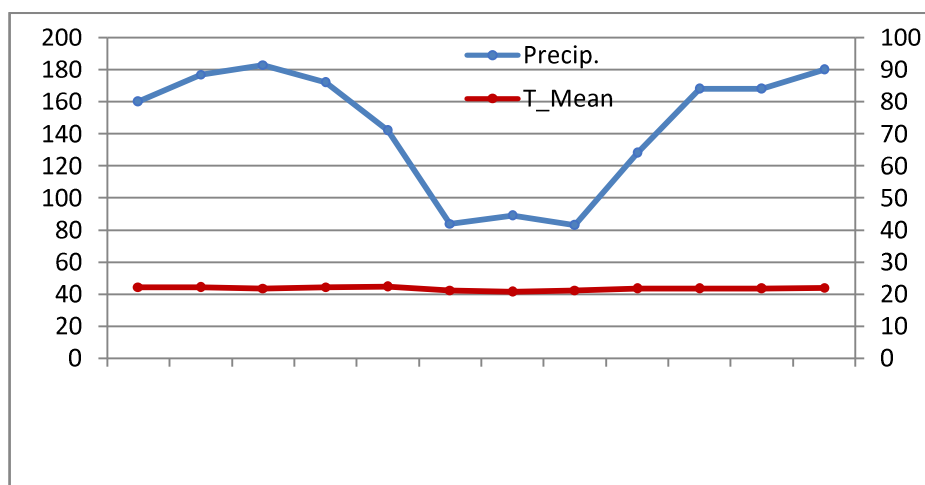
Fig. 7: Mean monthly temperature and precipitation of Menyamya (FAO LocClim data)

Meteorological data sets extracted from the FAO LocClim database displayed in figure 7 show mean monthly rainfall values ranging from 83 mm (August) to 183 mm (March) with one distinct dry season from June to August. Mean monthly temperatures remain constant throughout the year ranging between 20 and 22°C. Temperatures reach the mean maximum values during the day of approximately 27°C and the mean minimum during night time of approximately 16°C. Potential evapotranspiration (PET) rates reach the highest mean value in December with 193 mm and the lowest mean value in June with 126 mm. The mean PET values correspond to the variation of mean day time temperatures, which are slightly higher in December (28°C) and the lowest in June and July (26°C).

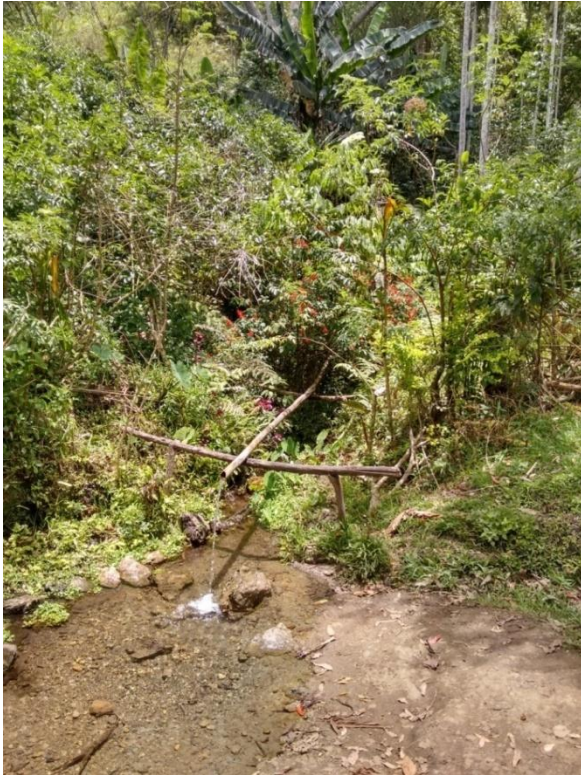
A bamboo pipe as shown in figure 9 is installed downstream of the spring to divert water for easy access. Flow rate however is very low.

Bamboo Pipe and free run-off at Vaya creek spring (main source). The spring is located a few meters upstream behind the bush and very close to the main road.

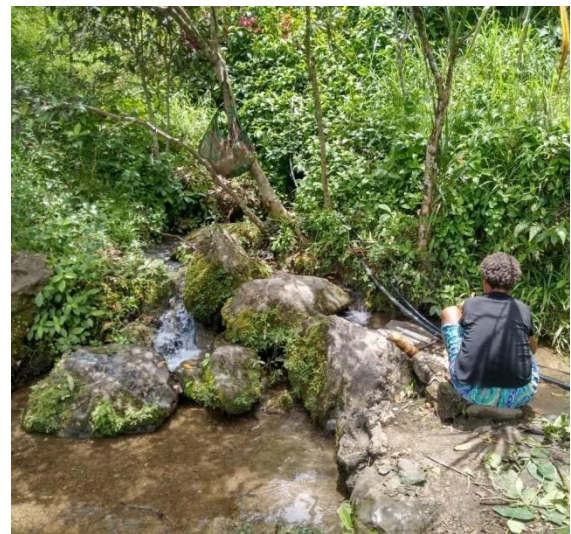
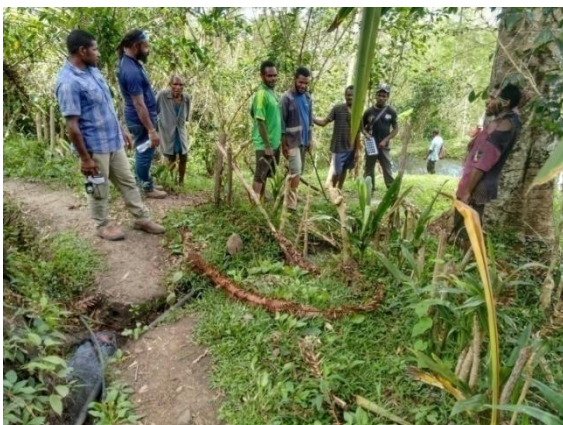
Fig. 9: Images across Vaya watershed

Pipe 1 and 2 nearby main inlet & sources. This location is just a few meters below the main road.

Pipe 1 and 2 and earthen channel diversion to a fish pond

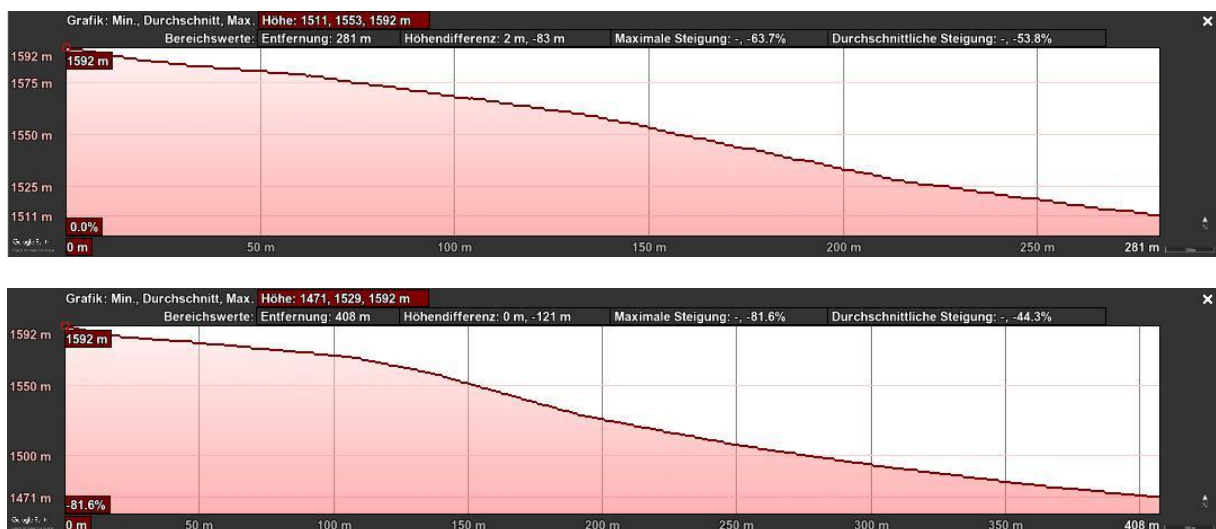
Fig: 10: Elevation profile of existing pipe 1 (above) and proposed extension of pipe 1 (below)

The elevation profiles for pipe 1, 2 and 3 and suggested extensions of these pipes are given in the figures 10, 11 & 12 below.

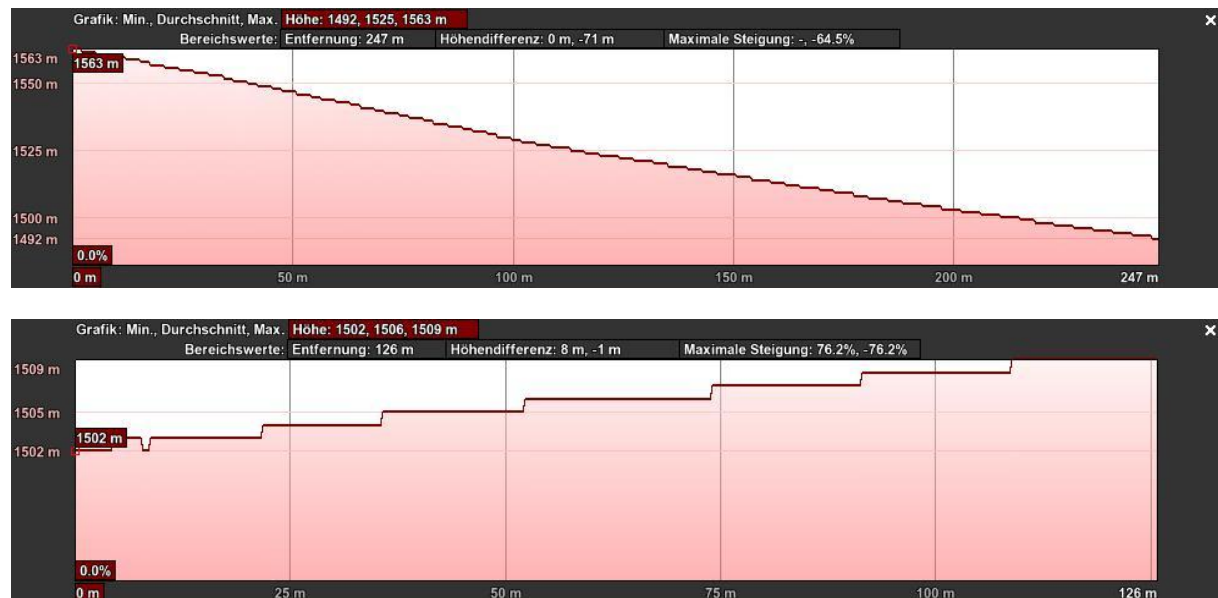
Fig: 13: Elevation profile of proposed down pipe (above) and delivery/supply pipe (below) for ram pump

Vaya creek and the topographic set-up of the area provide good scope to install a ram pump to supply water to the southern part of the community area. A possible location for the ram pump, down pipe and delivery/supply pipe is plotted in figure 8 (map B). The elevation profile of the down pipe supplying water to the ram pump and the delivery pipe are given in figures 13. The delivery height for the ram pump for the suggested location is app. 8m.

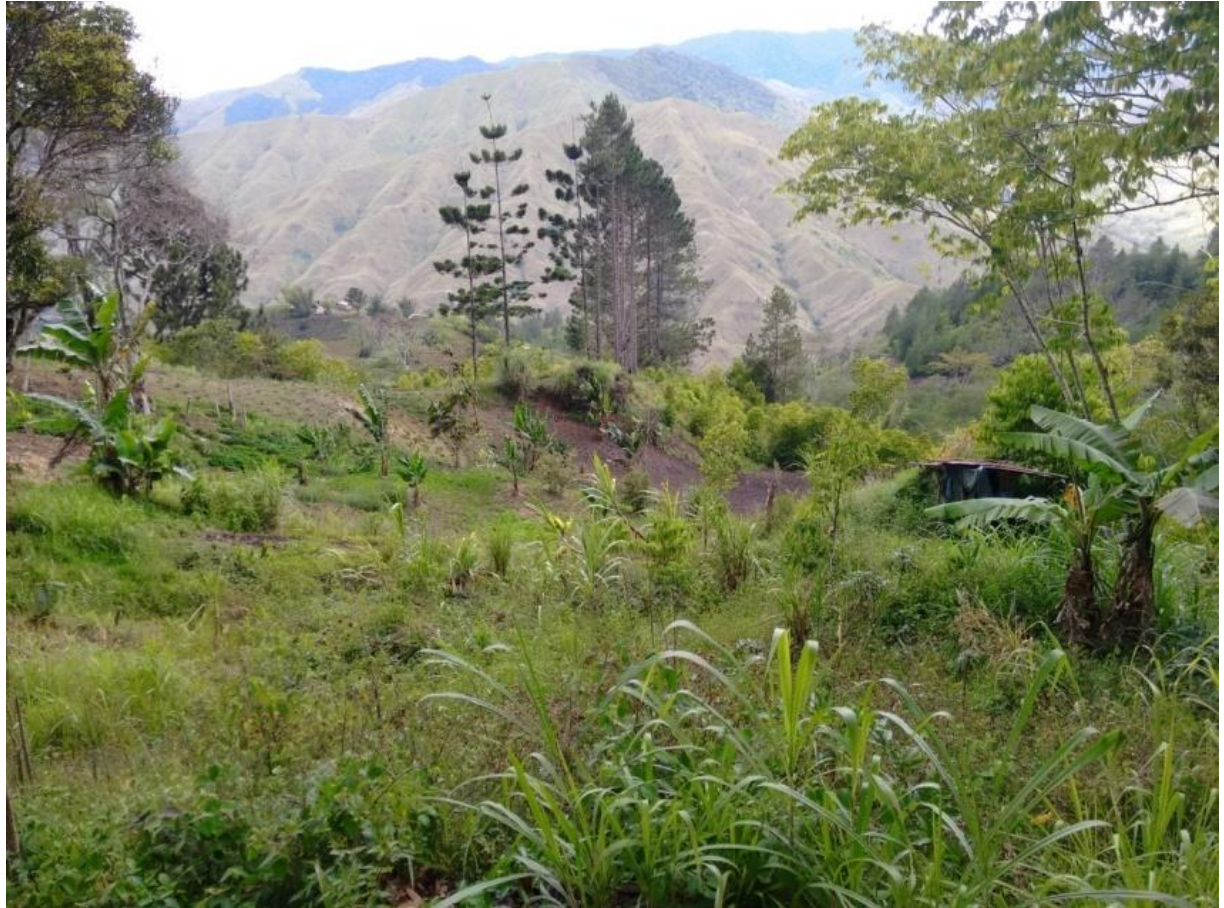
Fig. 15: Image of plot where flood irrigation is practiced during drought

Community members mentioned that irrigation is practiced as required according to weather conditions. For this purpose, earthen channels were dug to divert the water from Vaya creek to the fish ponds and to some food gardens in the upper part of the watershed (map D, figure 14). During the transect walk a number of silted up nonfunctional channels were identified. Those channels were used to convey water to various parts of the cultivated land. The reason for the discontinued use of the channels could not be determined. The channels which supply water to the fish ponds in vicinity of the main water source however are functional and in use. This is however a clear indication that some sort of flood irrigation was practiced during very dry periods, which provides a good scope for irrigation interventions. The introduction of higher value crops like vegetables can be a good entry point to promote irrigation and increase the capacity of farmers to use irrigation as a measure to reduce climate change related impacts on food security.

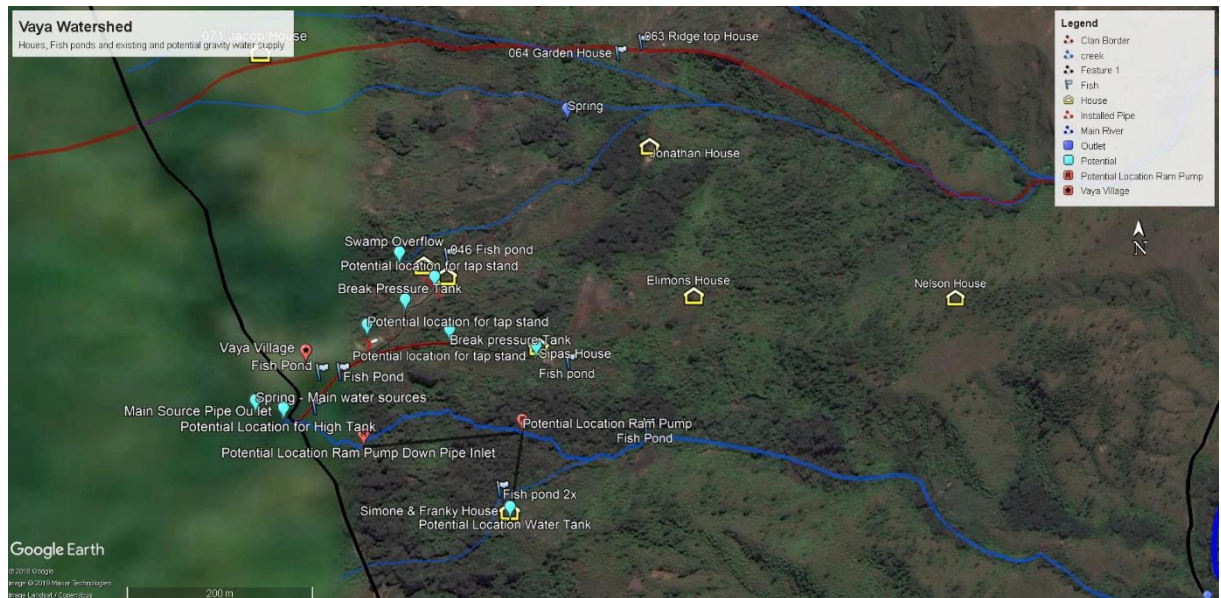
Fig. 16: Locations of homesteads and fish ponds across Vaya community (map C)

A moderate number of fish ponds are located throughout the slopes and valleys. The fish pond system is not overly complex and is of good construction although some ponds have water seepage problems which potentially damages coffee crops which surround them.

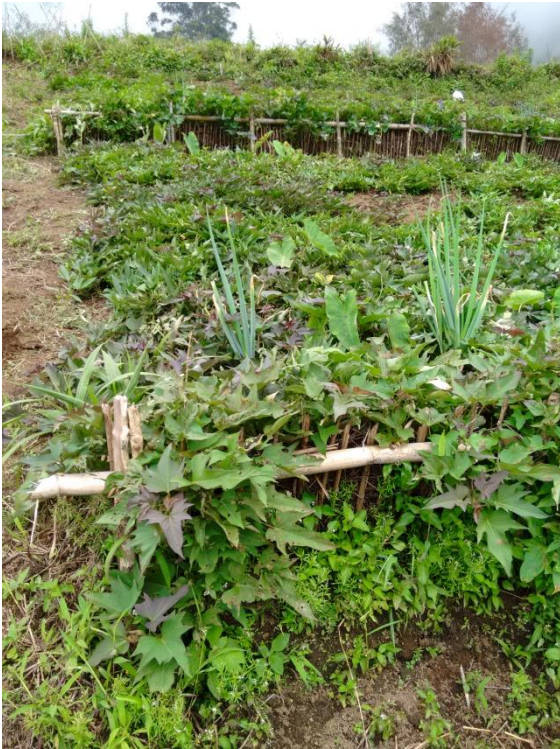
Fig. 17: Traditional terracing technique ('kekai')

This traditional technique as shown in figure17 is practiced in Gilang village, Selepet LLG, Kambwum district. Communities adapted their cropping technique to the steep slopes and obvious high water run-off rates which potentially lead to soil erosion by using a traditional terracing technique ('kekai'). Barriers along the contour lines are built using a mesh made of branches patched with top soil. This technique reduces water run-off and soil erosion but also retains soil moisture for productive use. Shifting cultivation is practiced whereby plots are left fallow to restore soil fertility.

Traditional terracing technique ('kekai') practiced in Gilang village, Selepet LLG, Kambwum district.
